Technical Report CHL-97-13  
July 1997

*Monitoring Completed Navigation Projects Program*

## **Monitoring of Harbor Improvements at St. Paul Harbor, St. Paul Island, Alaska**

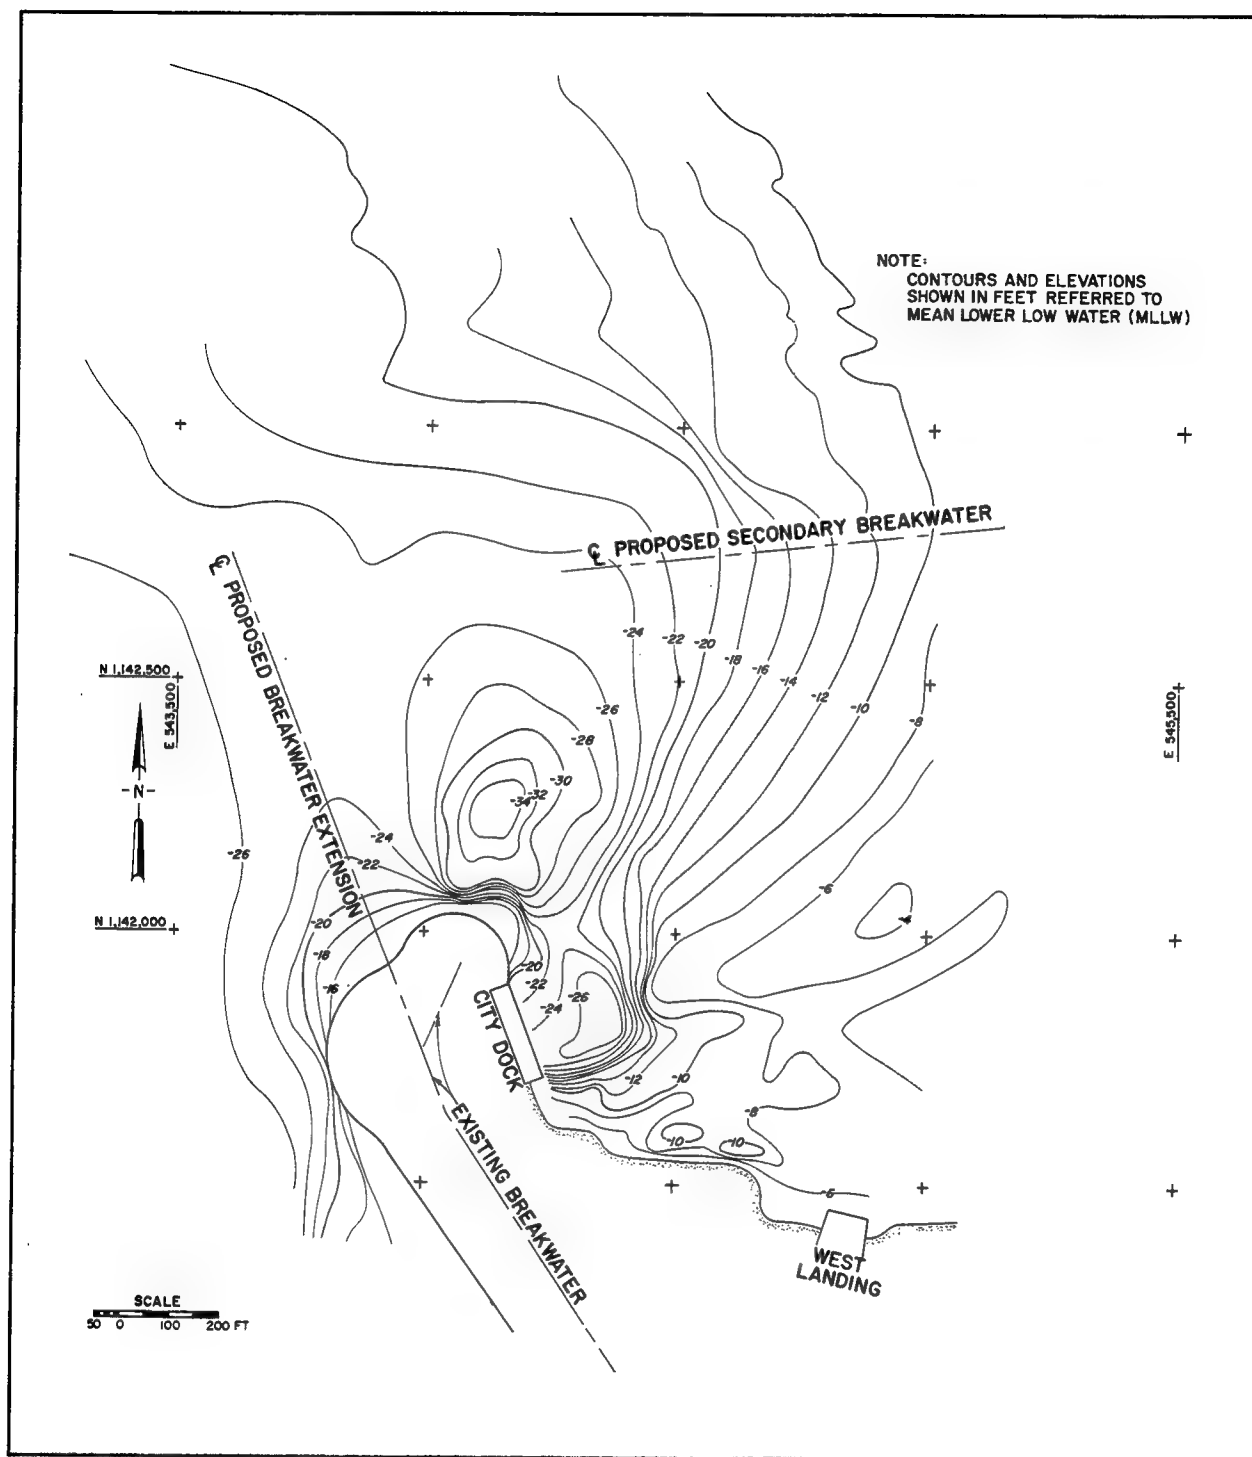
Figure 24. Bathymetry at St. Paul Harbor, September 1986

Bathymetric data obtained in and adjacent to the harbor in September 1986 (prior to construction of breakwater improvements) are shown in Figure 24. Note the 10.4-m (34-ft) el scour hole adjacent to the head of the breakwater. The scour hole formed after construction of the original 229-m-long (750-ft-long) breakwater in 1985. It was monitored by CENPA and did not tend to undermine the breakwater foundation. Depths adjacent to the vertical-walled, concrete caisson City Dock were dredged to greater than 6.1 m (20 ft). Though not shown in the bathymetry, CENPA noted that the cove appeared to begin filling in after initial breakwater construction with accretion along the southeast shoreline of Village Cove. At one point the connecting channel between the cove and saltwater lagoon was plugged and subsequently artificially reopened.

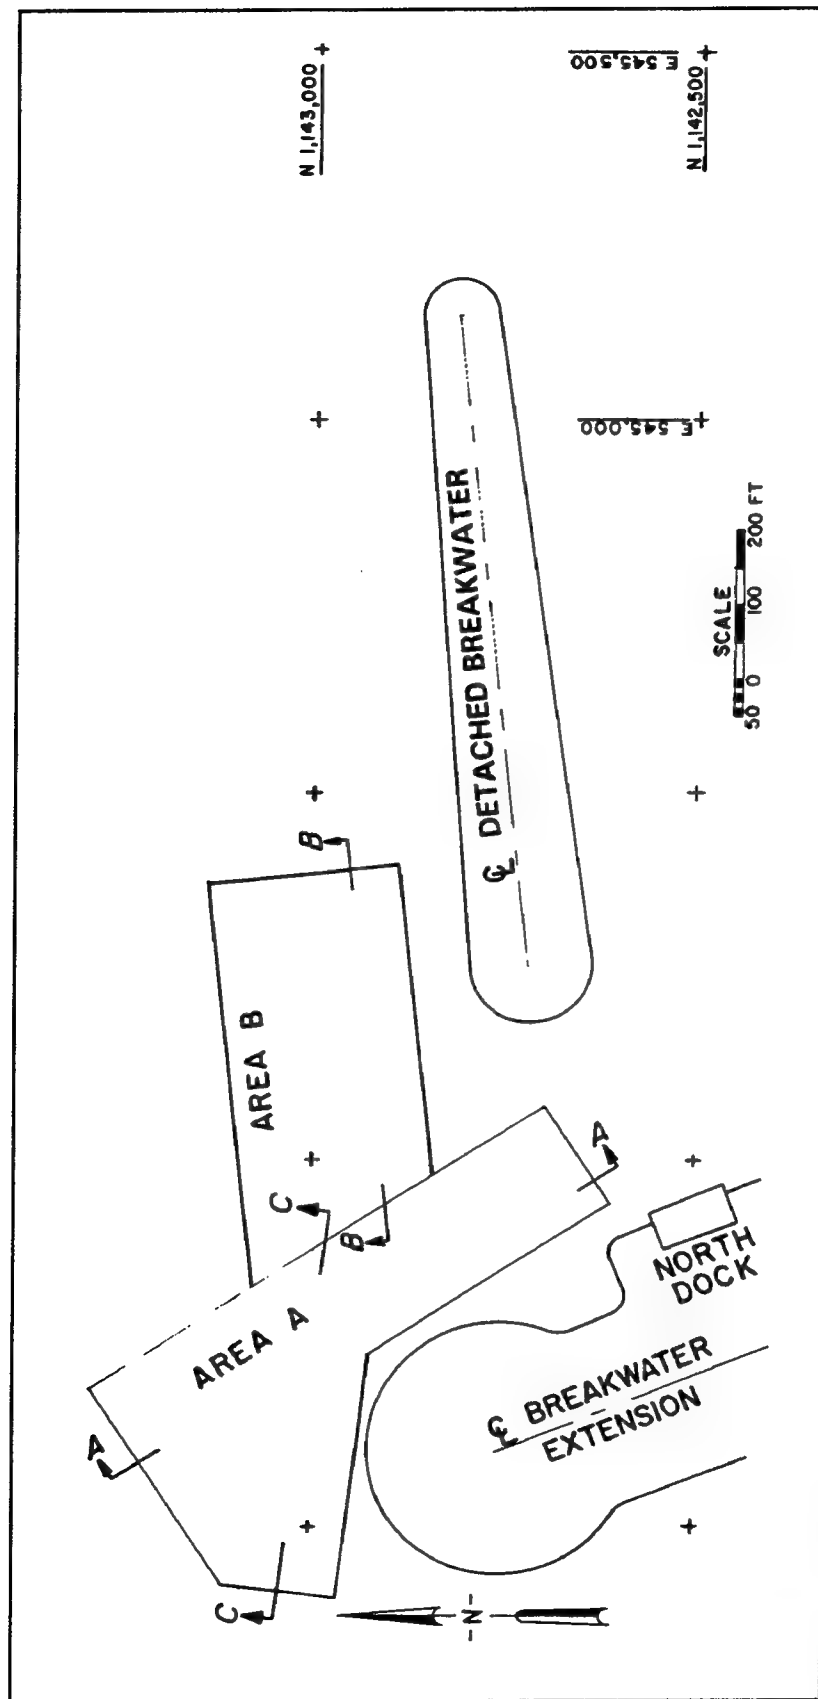
Figure 29. Areas at harbor entrance selected for detailed analysis

In an effort to better quantify scour and fill conditions at the harbor entrance, two areas were selected for more detailed analysis. Figure 29 presents the areas identified. Area A consists of 15,500 sq m (166,800 sq ft) and was initially used to determine scour adjacent to the head of the breakwater extension; Area B includes 11,770 sq m (125,700 sq ft) and was used to depict accretion across a portion of the entrance. Detailed bathymetry (0.3-m (1-ft) intervals) for Areas A and B are shown in Figures 30 through 32 for the 1986, 1992, and 1995 surveys, respectively; and

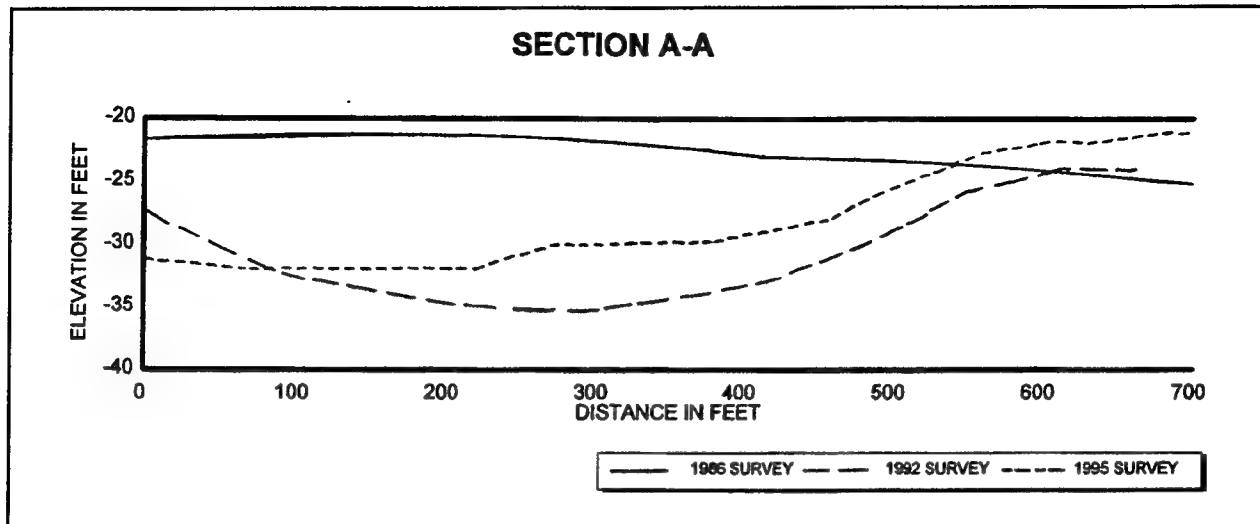
Figure 33. Cross sections through Area A, Section A-A for 1986, 1992, and 1995 surveys

cross sections through Areas A and B (at locations shown in Figure 29) are presented in Figures 33 through 35 for the various surveys. Contours of bathymetric changes that occurred between September 1986 and August 1992 are shown in Figure 36, and those occurring between August 1992 and July 1995 are presented in Figure 37. Erosion and accretion volumes were calculated for each area. Results indicate that, during the period 1986 through 1992, approximately 31,960 cu m (41,800 cu yd) of scour occurred in Area A and about 13,070 cu m (17,100 cu yd) of accretion occurred in Area B. This was the result of post-breakwater modifications. Between 1992 and 1995, Area A accreted about 4,660 cu m (6,100 cu yd) and Area B accreted approximately 5,350 cu m (7,000 cu yd) of material. Net volumes (between 1986 and 1992) are 27,300 cu m (35,700 cu yd) of scour in Area A and 18,420 cu m (24,100 cu yd) of fill in Area B.

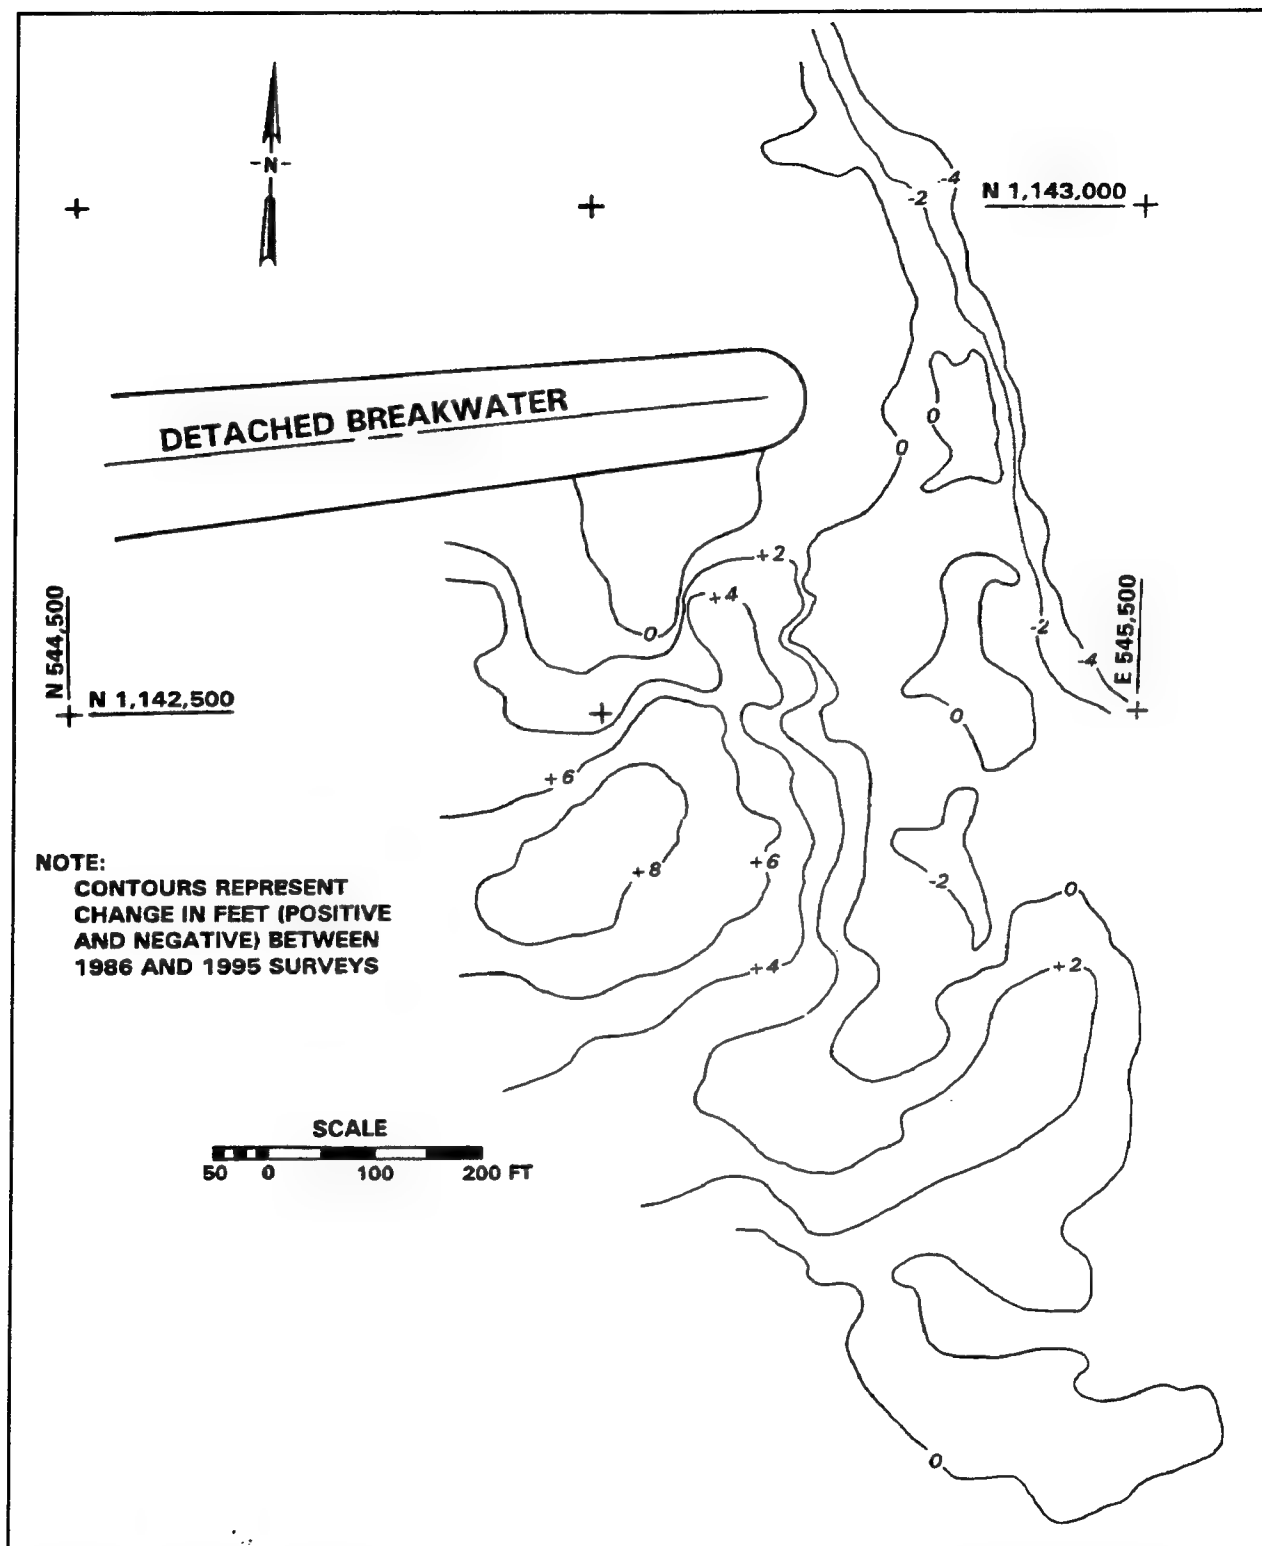
Figure 38. Contours of bathymetric changes in the lee of the eastern end of the detached breakwater between September 1986 and July 1995

The July 1995 survey was more comprehensive than the August 1992 survey in that it included more bathymetry inside the harbor. To determine changes as a result of the opening between the detached breakwater and the shoreline, the July 1995 survey was compared to pre-breakwater conditions (September 1986 survey). Contours of bathymetric changes in the lee of the eastern portion of the detached breakwater were prepared. Data indicate accretion of 2.4 m (8 ft) in areas inside the harbor between 1986 and 1995, as shown in Figure 38.

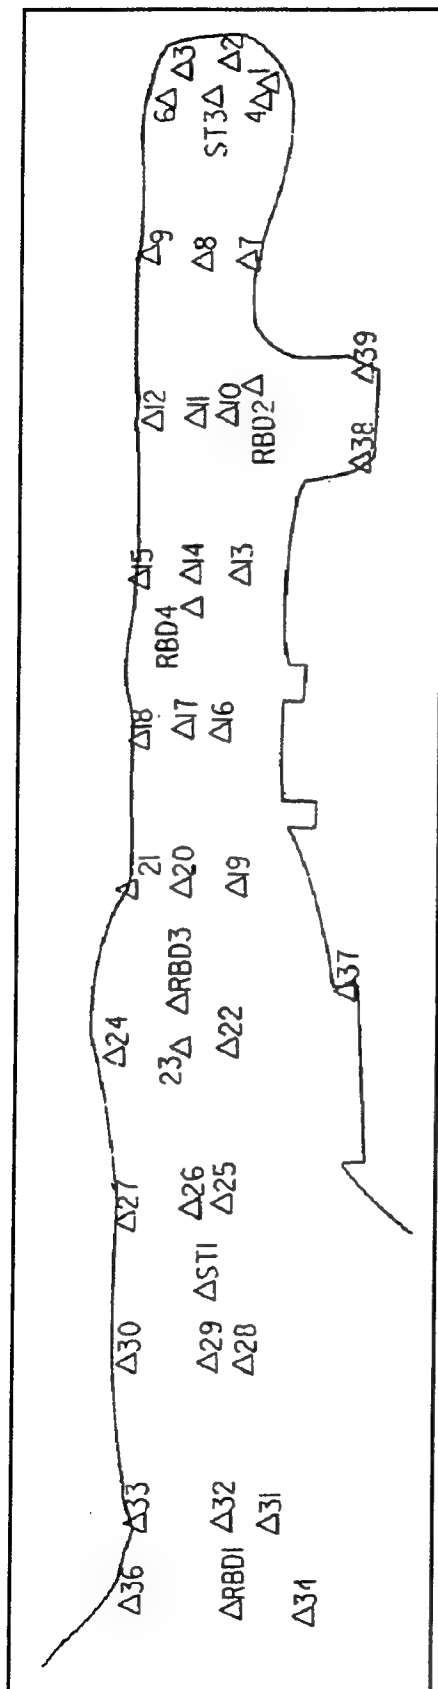
Figure 44. Locations of monuments and targets for 1994 survey

Prior to the photogrammetric survey work for the St. Paul Harbor main breakwater, limited ground surveys were conducted. Monuments and targets established on the breakwater are shown in Figures 44 and 45 for the May 1994 and May 1996 surveys, respectively. Positions and elevations of the monuments/targets are presented in Table 6 for the two surveys. Although slight movement may have occurred between 1994 and 1996, the 1994 control points were used for truthing during the 1994 photogrammetric flight and the 1996 control points for the 1996 photogrammetric flight. In some cases, targets were re-established.
